XS1100H/LH/SH
DRIVE AXLE BEARING COLLAR

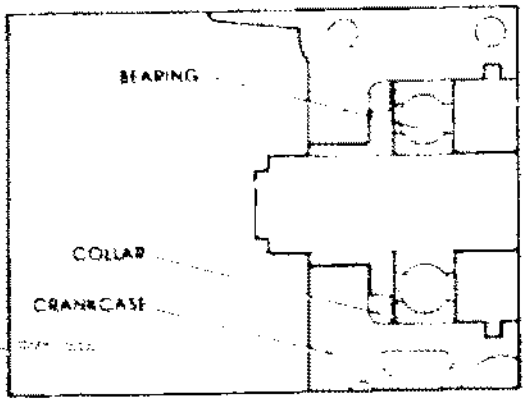
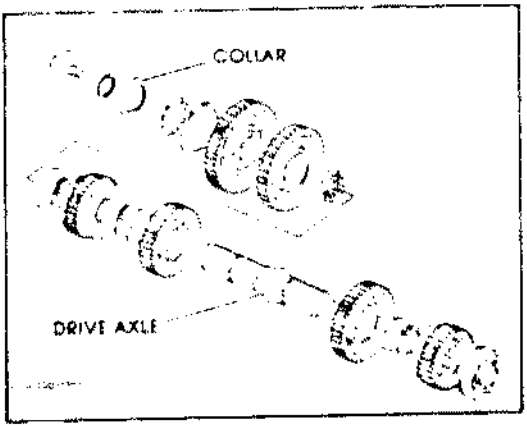
A new-style bearing supports the right-hand side of the transmission drive axle on the affected models. This new-style bearing is a single-row ball bearing rather than a double row bearing as used in previous XS11s. Since the new-style bearing is 3mm narrower than the bearing previously used, a collar has been installed between the bearing and the crankcase to maintain the proper clearances in the transmission. This collar is directional; it must be installed with the beveled edge toward the crankcase and away from the bearing.

If the collar is positioned improperly during assembly, the crankcase will be damaged when the drive axle bearing is installed. Be sure the bearing collar is installed correctly before pressing the drive-axle bearing into the crankcase.
