YAMAHA MEASURE REPORT

MODEL	TDR240/250, TZR250	FILE	
SUBJECT	PISTON MELTING AT CROWN

MODEL	TZR250 '87, '88	FILE	
SUBJECT	PISTON SEIZURE

MODEL	TZR250 '87, '88	FILE	
SUBJECT	PISTON RING BREAKAGE

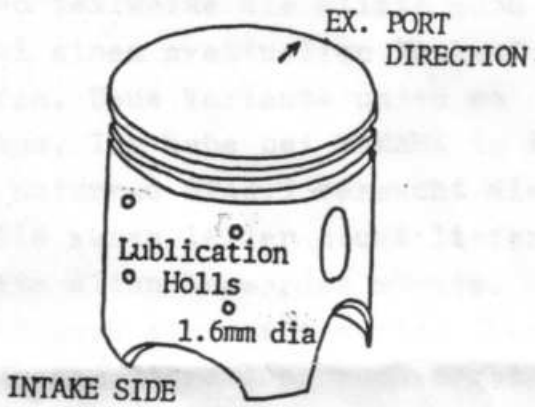
Market report indicate knocking engine noise and piston seizure.

At the early breake-in of an units, some units may be experienced scaffing between piston and cylinder wall insurficient lublication. Then scaffing caused to piston seizure.

To prevent scaffing at early breake-in, we are going to change the piston desigen as similure with 2YK type (TDR250) as a next model. The 2YK type piston has four location of lublication hoils at intake side as shoun in the left. These holls will provide greator lublication effect between piston and cylinder wall comparison with present ones.

If you encounter a smilure problem, please recommend your dealer to use following part instead of STD ones. Recommended piston is as same as TDR250 model's one.

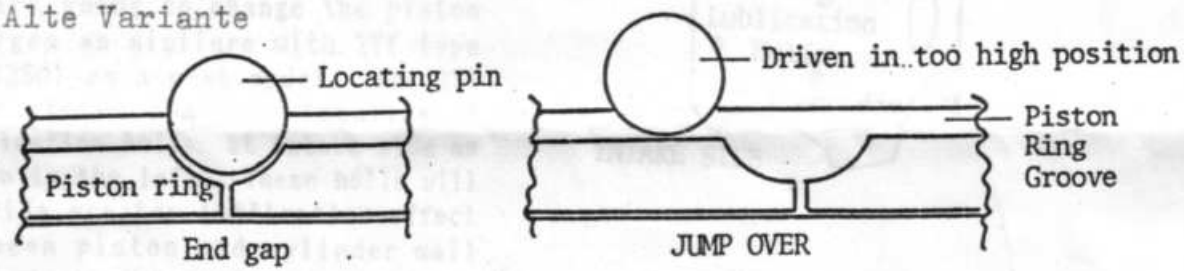
Alte Variante

Market report indicates that the a piston ring is broken catching with cylinder port.

The piston ring located pin may be experienced driving into piston ring groove with insurficient dimension accuracy in some units (drivig upward'comparison with specified location) . And also locating pin can be worn. These matter may cause that piston ring end gap can jump over the locating pin and then end gap will catch with cylinder ports. See below.
